Superconducting Transformer Failure: Testing and Investigation

Irvin Chew, Andrew Lapthorn, Pat Bodger and Wade Enright
Electrical and Computer Engineering
University of Canterbury
Christchurch, New Zealand
Email: iec16@student.canterbury.ac.nz

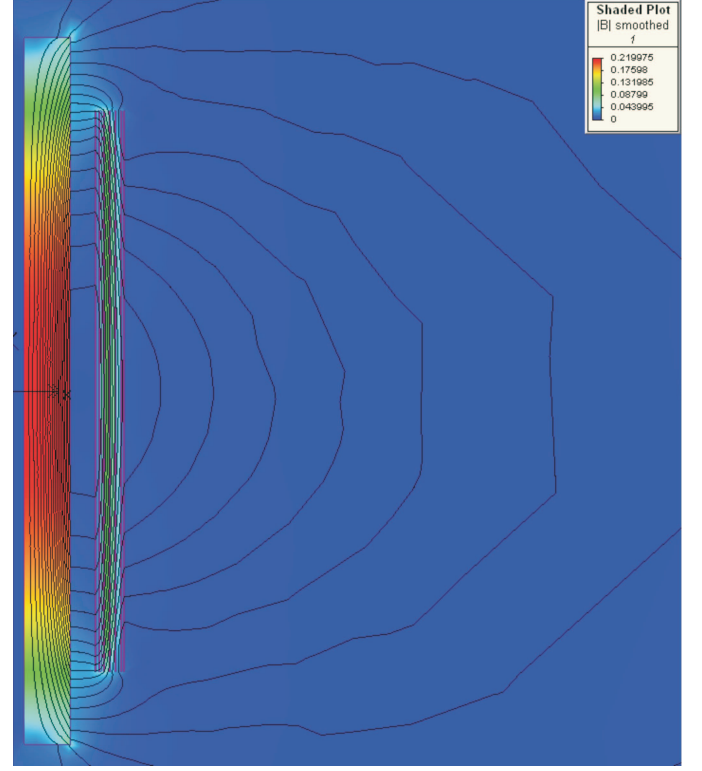
The peak magnitude of the flux as indicated by Magnet was 0.03T at right-angles to the tape plane on the first turn at the ends of the inside winding. The critical current is lowered due to this radial flux and is modelled by Oomen et al[3]. The formulas described in Oomen et al were obtained via empirical studies on a 1MVA Siemens railway transformer in Germany. The critical current of the superconducting tape

Fig. 5. Flux plot of the superconducting transformer under full load conditions.

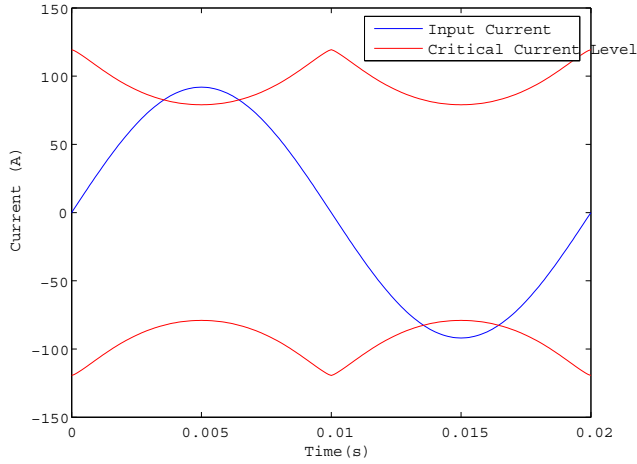
Using Equation 1, the critical current was lowered to 79.03A from its 120A nominal rating. The input current waveform only spends 6 milliseconds per cycle above 79.03A (Figure 6).

Fig. 6. The input current waveform of the superconducting transformer exceeding the critical current level calculated in equation 1.

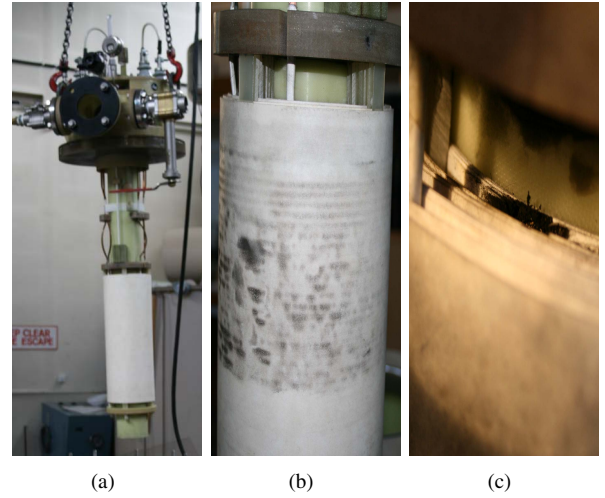
The transformer windings were then taken out of the cryostat for investigation (Figure 7). Figure 7(c) shows burnt out insulation which indicates that a small section of superconductor has burnt and open circuited the winding. Contaminant marks on the insulation are also observed in Figure 7(b). The carbon scorches and ring marks, due to combustion, gives evidence of the presence of oxygen. With the transformer submerged in liquid nitrogen, some of the oxygen from the atmosphere could have been condensed into liquid form creating a liquid nitrogen and oxygen mix. Another source of oxygen could be from the air voids in the insulation or air bubbles trapped between the insulation and the windings. The air winding chamber was not evacuated, only displaced by the liquid nitrogen when filling. This suggests that the transformer should have had the air evacuated from the chamber prior to filling.

Looking at the construction of the transformer, the windings and insulation were packed tightly together. It did not have any cooling channels for liquid nitrogen in between the windings. Unfortunately there were no temperature readings for the inside windings when the tests were done.

Fig. 7. Damage caused to the superconducting transformer during full-load endurance run; (a) before full-load endurance run failure, (b) contaminants sticking onto the insulation after transformer failure and (c) insulation burn damage from the blown superconductor.

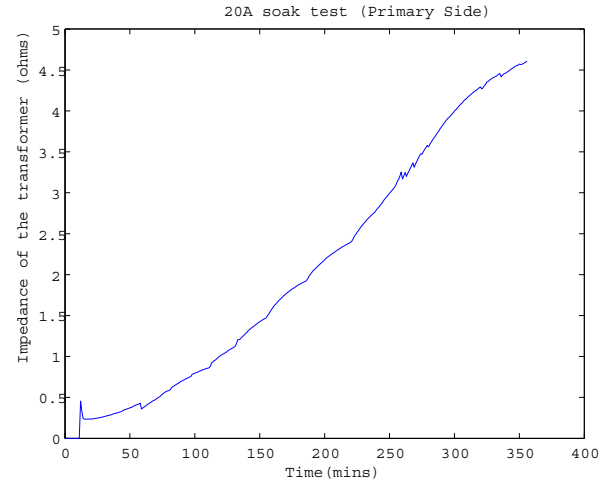
Fig. 8. Transformer impedance during the 6 hour 20A endurance run

The resulting impedance from these readings shows that it steadily increased over time (Figure 8). At the end of the 6 hour test, it was visually observed that the liquid nitrogen was boiling off at a faster rate compared to that at the beginning of the test. This indicates that the shorted turn is no longer superconducting and the silver metal matrix was slowly heating up hence increasing the overall transformer impedance.

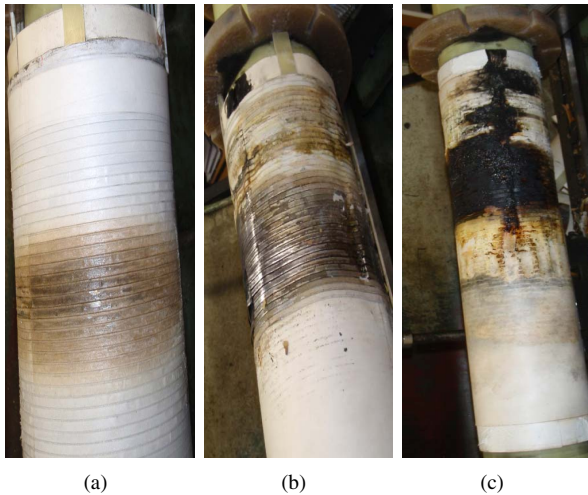
Fig. 9. Transformer winding burns (a)outer layer of the middle winding, (b)outermost layer of the inside winding and (c)innermost layer of the inside winding.

The transformer windings and insulation were taken apart to visually inspect the faulty turn(s). Two layers of the outermost winding (secondary winding) were found unharmed, only superficial damage (Figure 7(b)) appeared on the surface of the Nomex paper insulation. The first signs of winding damage appeared on the outer layer of the middle winding (Figure 9(a)). Melted glue residue was found on the insulation which indicates that the windings heated the Nomex tape glue to boiling point. The damage to the transformer got worse as more windings and insulation were removed. The Nomex tape on the superconductor on the outermost layer of the inside winding was completely burnt (Figure 9(b)). Figure 9(c) shows a whole section of superconductor that has been warped due to expansion and contraction. The ends of the innermost layer of the primary winding were burnt and disconnected, evidence of carbon suggests that combustion was the cause.

The damage appeared mostly around the center of the inside and middle windings, which suggests that the windings were packed too tightly together to allow sufficient cooling. The ends of the windings were relatively unscathed due to it being exposed directly to liquid nitrogen. This indicates that the superconductor in the inside of the innermost layer quenched due to the temperature rise. A cascading effect ensues which led to the superconductor burning and disconnecting the primary layer. Further heating caused insulation damage on the outer

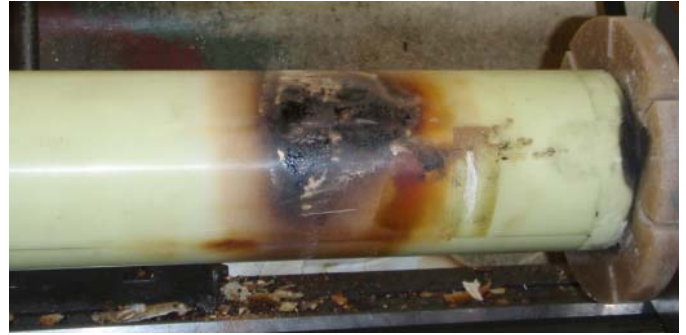
layers of the inside and middle windings. Figure 10 shows the resultant damage on the winding former. The damage appears to be superficial and the vacuum chamber is still intact.

Fig. 10. Damage on the winding former
